Valuation and Report

Webbs Factory, Bunting Road, Northampton, NN2 6HU

Inspected **12 March 2014**

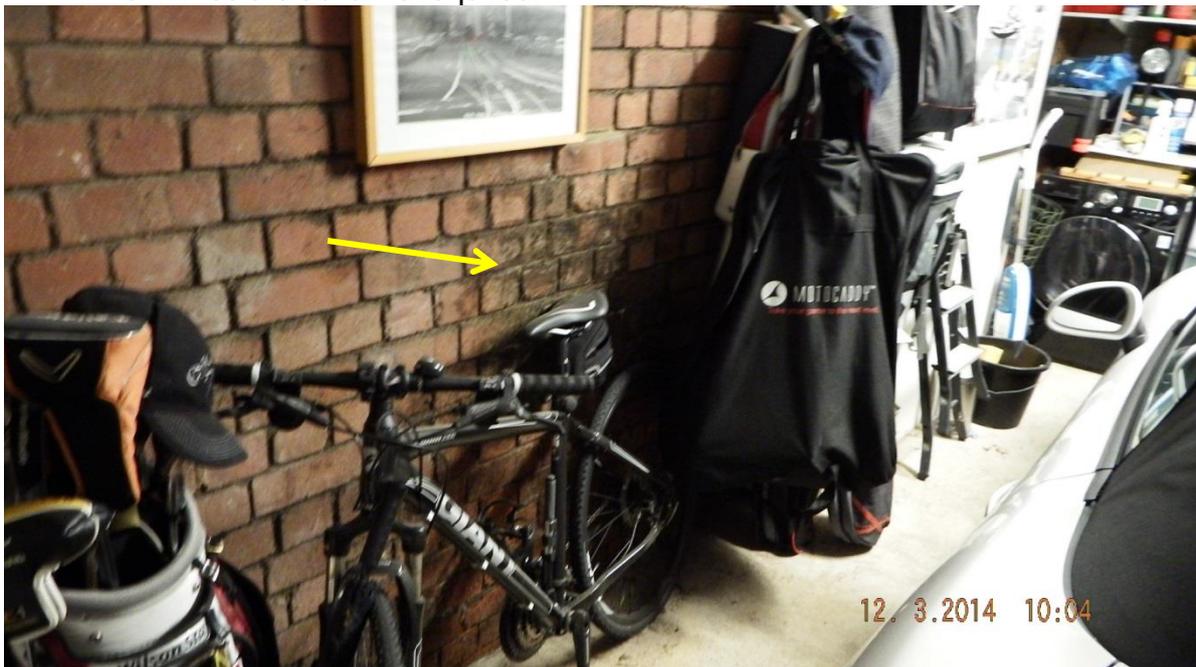
1. There is some staining to the garage wall where a previous leak existed. The leak has now been repaired. The detailing to the external gutter in this location is not ideal and unless kept clear from debris the leak could re-occur.
2. Minor deterioration to the front door and frame was noted with early signs of wet rot. External maintenance and decoration will be needed to prevent further deterioration.
3. There is some very minor cracking to exposed brickwork to internal wall areas. No immediate action is required.

Staining to garage wall from leak. Tested dry and can be cleaned off.

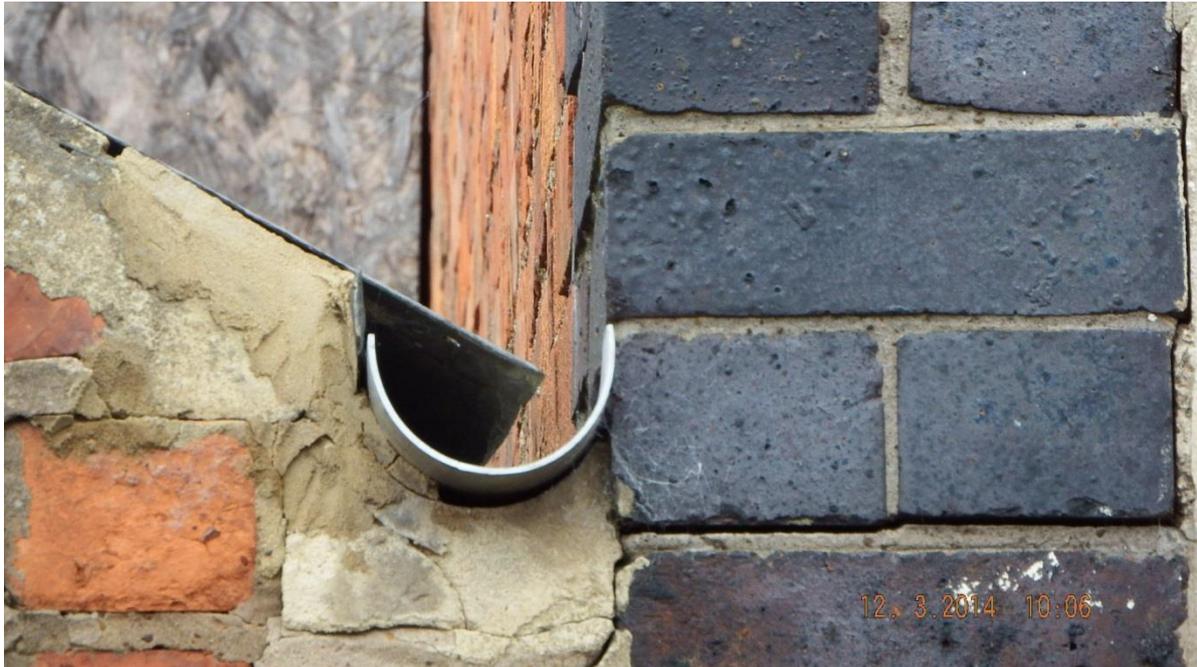
This gutter run became blocked and leaked into the garage. The lack of any downpipe will allow water to discharge onto the face of the wall

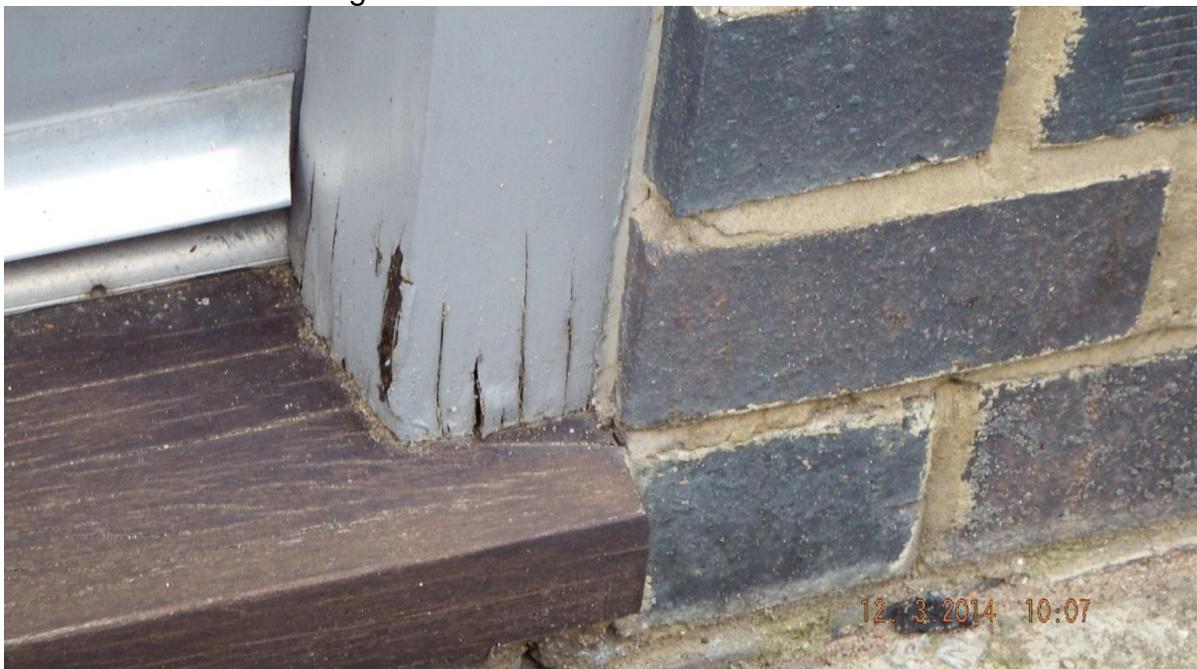
Deterioration to door frame

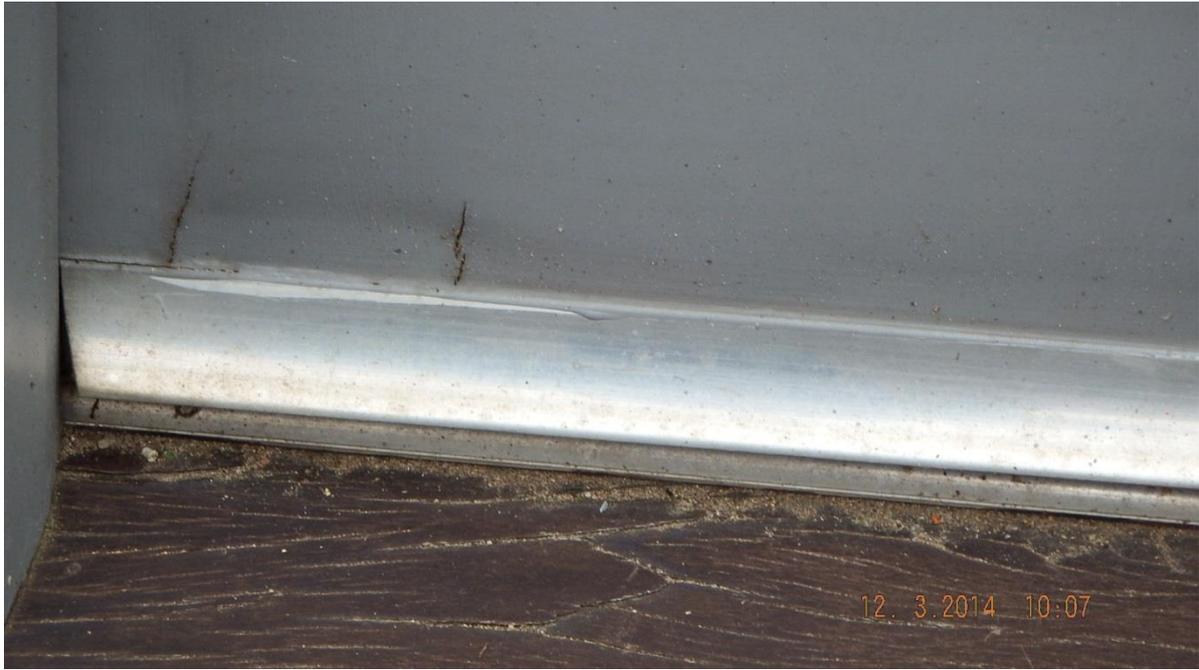
Deterioration to front door

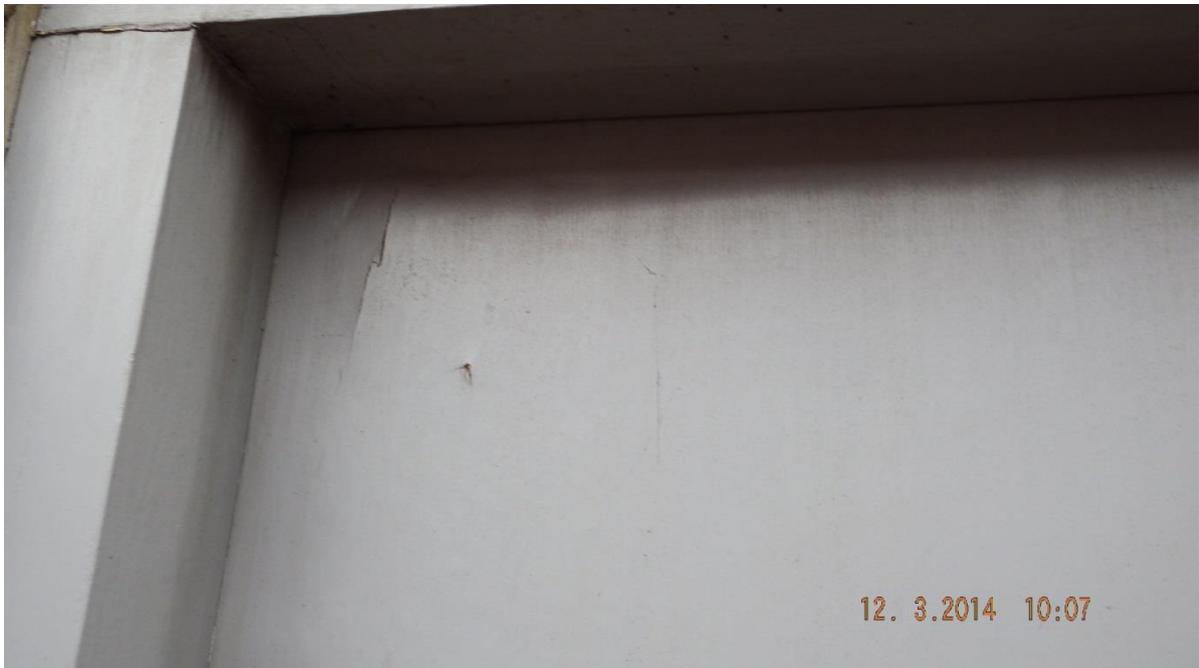
Upper part of door is splitting
