RICS  
**HomeBuyer** Report

Property address

Wellingborough, NN8 1EH

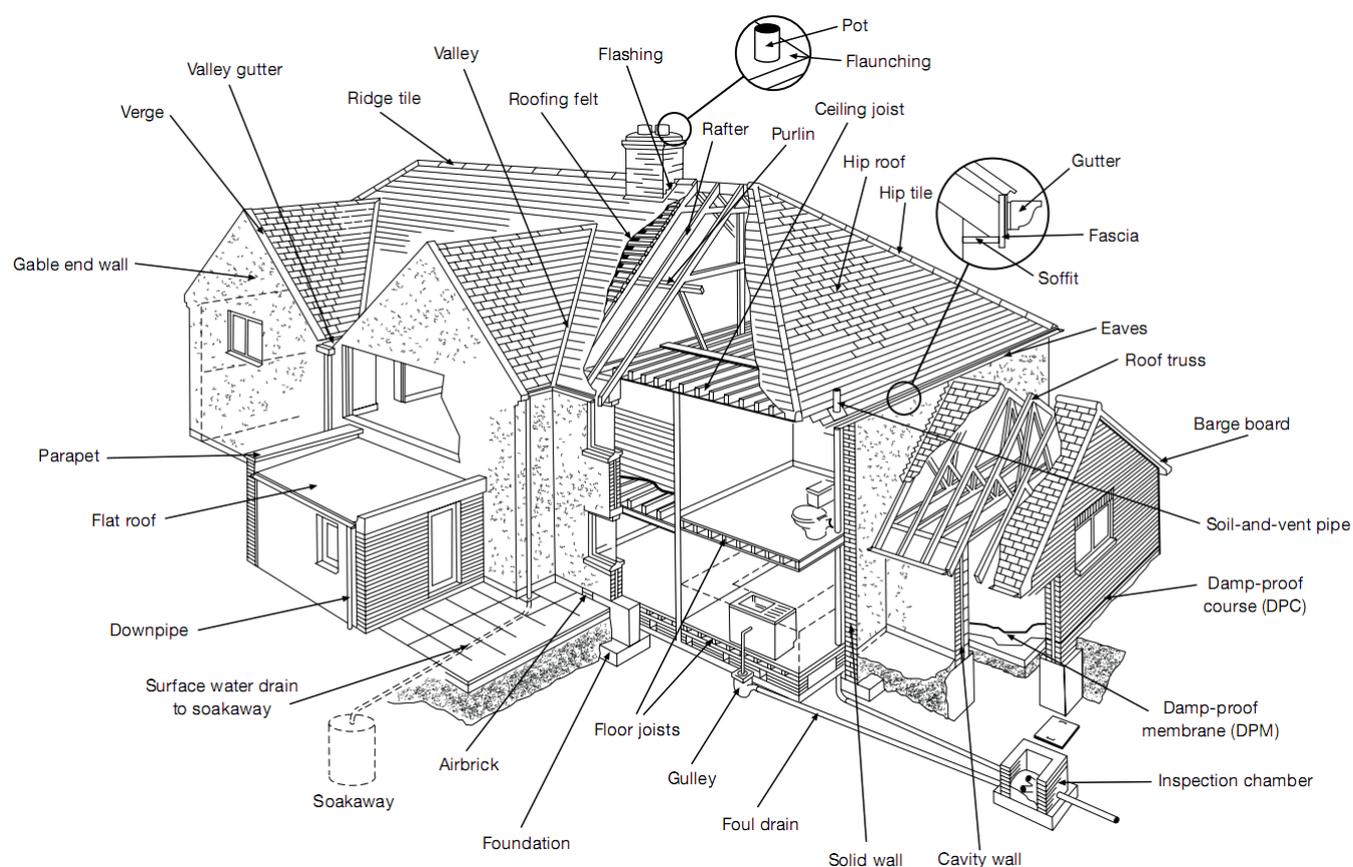
# Typical house diagram

This diagram illustrates where you may find some of the building elements referred to in the report.
